**BULLETIN OF THE
SERVICE CITIZENS OF DELAWARE**

**GENERAL REPORT ON
SCHOOL BUILDINGS AND GROUNDS
OF DELAWARE**

OCTOBER 15, 1919

**GENERAL REPORT
ON SCHOOL BUILDINGS AND GROUNDS
OF DELAWARE
1919**

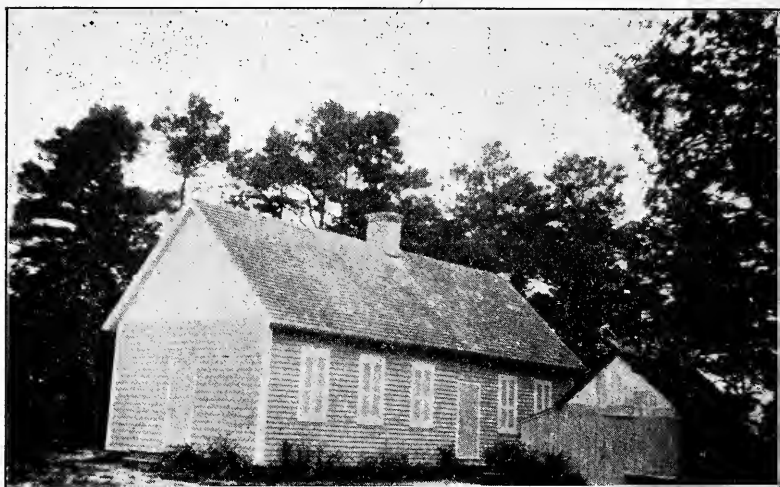
MIDWAY NO. 179

Score	Perfect Score
I. Site	56	160
II. Building	54	200
III. Service Systems	69	250
IV. Class Rooms	100	225
V. Special Rooms	3	165
	<hr/>	<hr/>
	282	1000

attempt to meet crowded conditions of a one-room school by stringing out a second room on the end of the original one-room structure. Apparently no expert advice had been sought in the construction of the building. The building is heated by an improved type of jacketed heaters, but the other elements of service systems are extremely poor. The toilets are located down in the woods where they are almost inaccessible. The class rooms which are approximately 18x22 and 18 feet square respectively, are poorly equipped and poorly lighted. As soon as the necessary steps can be taken to perfect consolidation so as to bring together a larger number of children in order that a graded school may be had, this school should be closed.

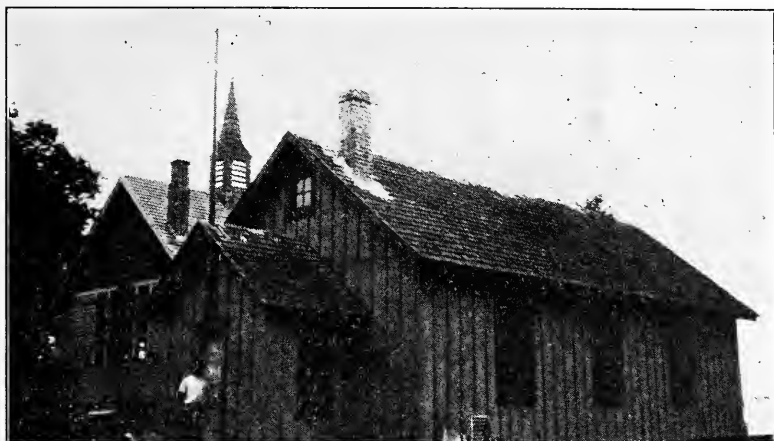
NEWPORT SCHOOL

Score	Possible Score
I. Site	29	160
II. Building	49	200
III. Service Systems.....	52	250
IV. Class Rooms.....	83	225
V. Special Rooms.....	1	165
	<hr/>	<hr/>
	214	1000

The Newport School for colored children is a one-room, rectangular, frame structure, very old and in poor condition. The environment of this school is a church, graveyard and potato patch. The site is scarcely larger than the building itself, and the entire situation is most deplorable. It is unfit in every respect for the housing of children.

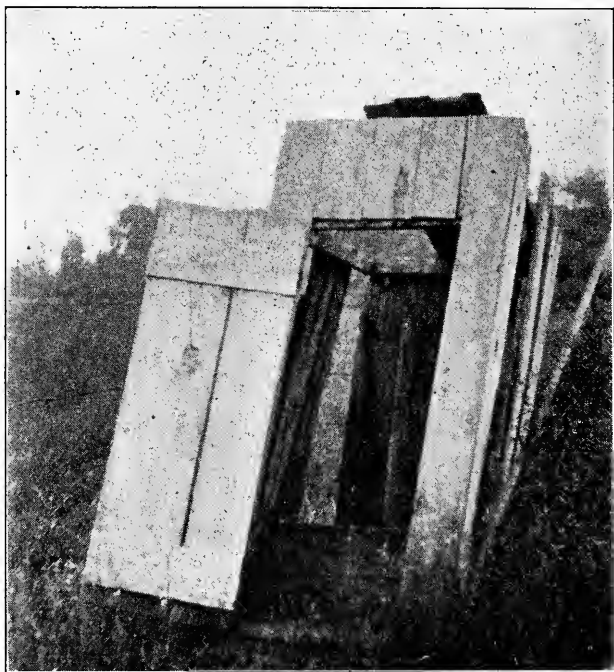
THE TOILET FOR THE COLORED CHILDREN OF THE WILLIAMS-VILLE SCHOOL, DISTRICT NO. 113, NEW CASTLE COUNTY

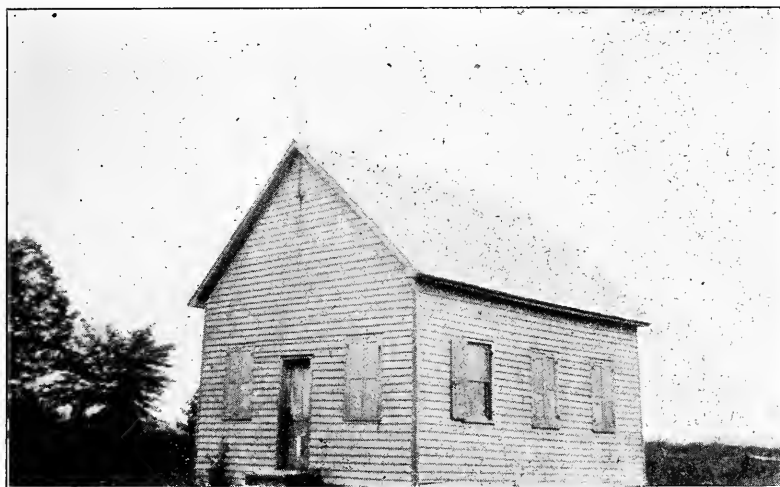
GLASGOW NO. 114

The Glasgow School is a four-walled, frame structure, without vestibule or protected entrance. It has a tin roof and is in general

bad state of repair. It is located on a small triangular plot of worthless land adjoining low, swampy ground. On no single item considered does the building justify its use for school purposes. The total score of 209 out of 1000 justifies the recommendation that this building be closed to school children.

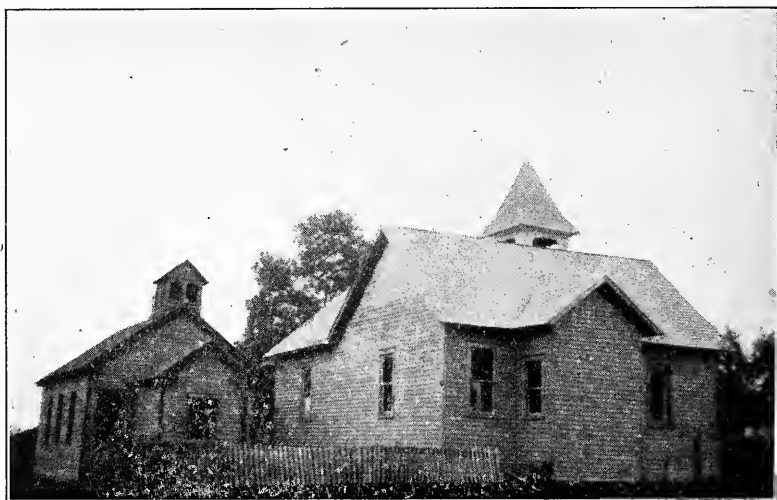
The school for colored children in St. Georges is a one-room, rectangular, vestibuled type of frame building, located on a small

site in the rear of the colored church. As clearly shown in the picture, there is no opportunity for play and little possibility of the development of an adequate recreational ground. The building is poorly equipped, poorly lighted and unfit for school purposes.

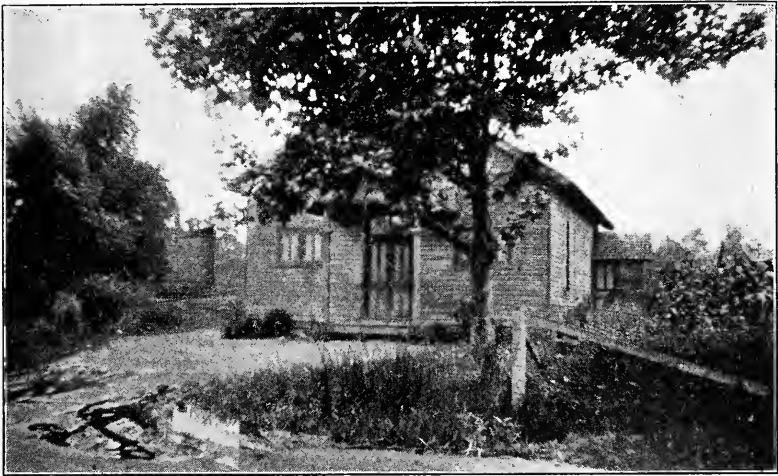
DELAWARE CITY DISTRICT NO. 118

NOTE--Marsh to the left with Canal boat back of it

The building itself, except for the Waterbury heater, is but little better than the environment in which it is placed. There can be little hope for the education or Americanization of children that are required to secure their education under conditions such as are found in this building.

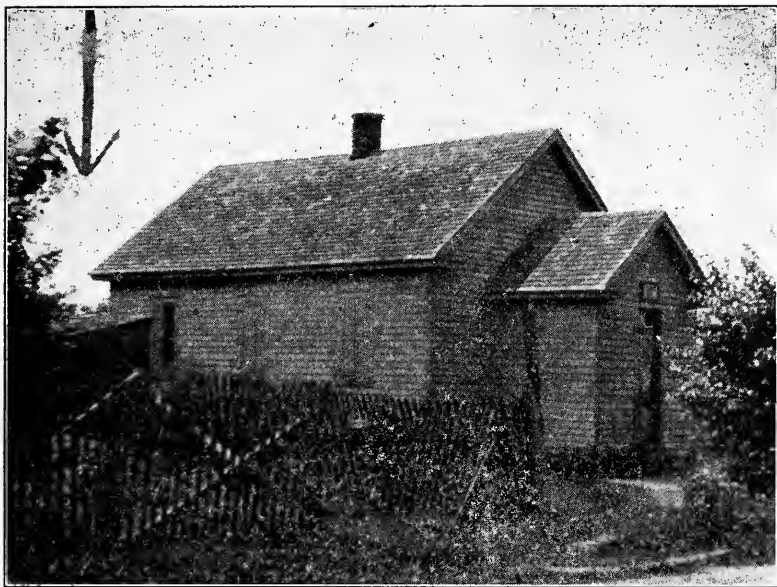
MT. PLEASANT SCHOOL

Score	Possible Score
I. Site	75	160
II. Building	89	200
III. Service Systems.....	28	250
IV. Class Rooms.....	89	225
V. Special Rooms.....	2	165
	<hr/>	<hr/>
	283	1000

Shelter and to a degree protection from cold, inclement weather is all this building has to offer the children that are supposed to attend it. It is disqualified and condemned on every major item of the score card and reference to the detail scores will further emphasize the educational lacks. It is of special note that this building has but one toilet for the two sexes and that in the class

Note arrow to the left of school house pointing to pig sty.

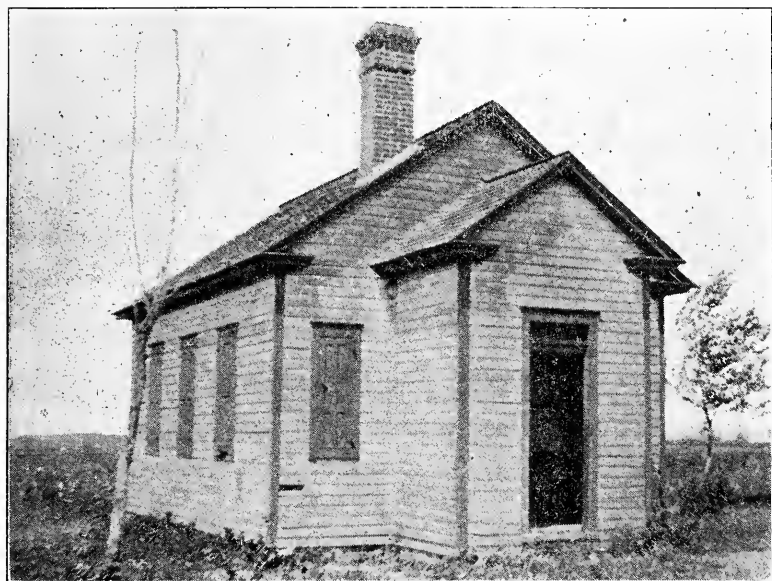
PORT PENN SCHOOL

Score	Possible Score
I. Site	73	160
II. Building	70	200
III. Service Systems.....	53	250
IV. Class Rooms.....	73	225
V. Special Rooms.....	2	165
	<hr/> 271	<hr/> 1000

Altho scoring above the medium for colored schools of the country, the Port Penn building is in every major respect far below acceptable standards. If the present location of the school should appear to be the most satisfactory, the size of the site should be extended by from four to ten acres and a properly planned building constructed. It seems fair to note that this colored school did have two toilets, altho they were in very unsatisfactory condi-

tion. The building is heated by a jacketed heater of good quality and in this respect is better than others of its class.

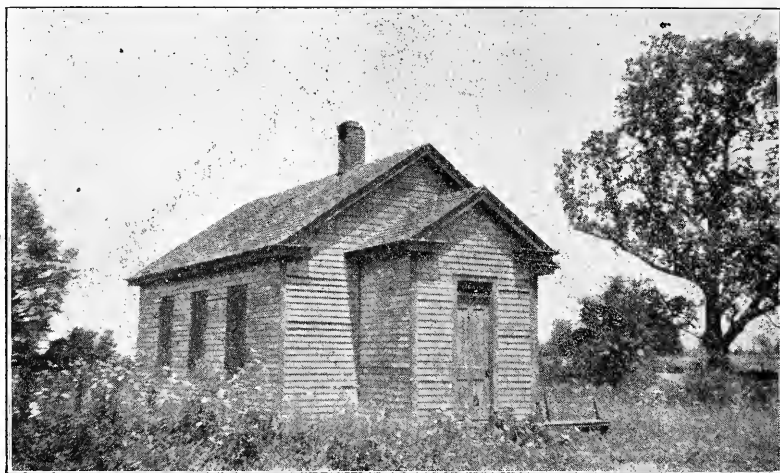
CONGOTOWN NO. 123

Score	Possible Score
I. Site	63	160
II. Building	54	200
III. Service Systems.....	22	250
IV. Class Rooms.....	57	225
V. Special Rooms;.....	2	165
	<hr/> 198	<hr/> 1000

This building has nothing commendable about it except the improved highway which makes it fairly accessible. Its environment is not pleasing; the site is so small as to be of no consequence and the little that is not occupied by the building is overgrown with briars and bushes. The two sexes are provided with but one toilet, the condition of which is very bad. The adequacy of the class room is indicated by the very low score of 57 points out of 225. The building should be closed for school purposes and the site abandoned.

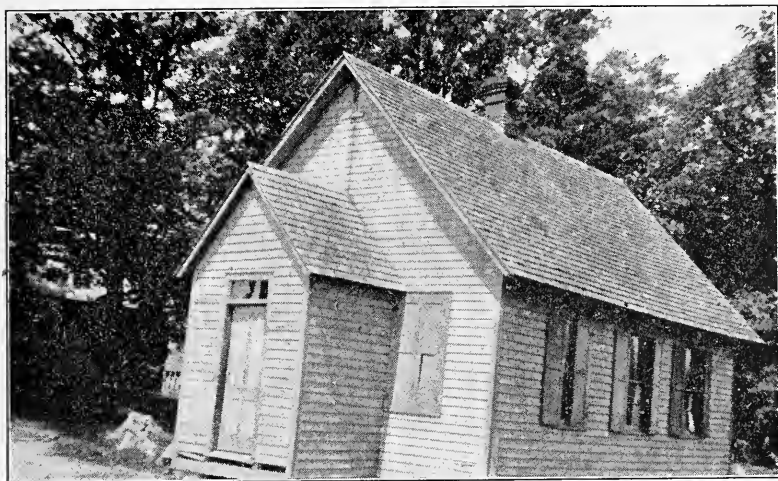
EBENEZER DISTRICT NO. 126

Score	Possible Score
I. Site	17	160
II. Building	60	200
III. Service Systems.....	25	250
IV. Class Rooms.....	75	225
V. Special Rooms.....	0	165
	<hr/> 177	<hr/> 1000

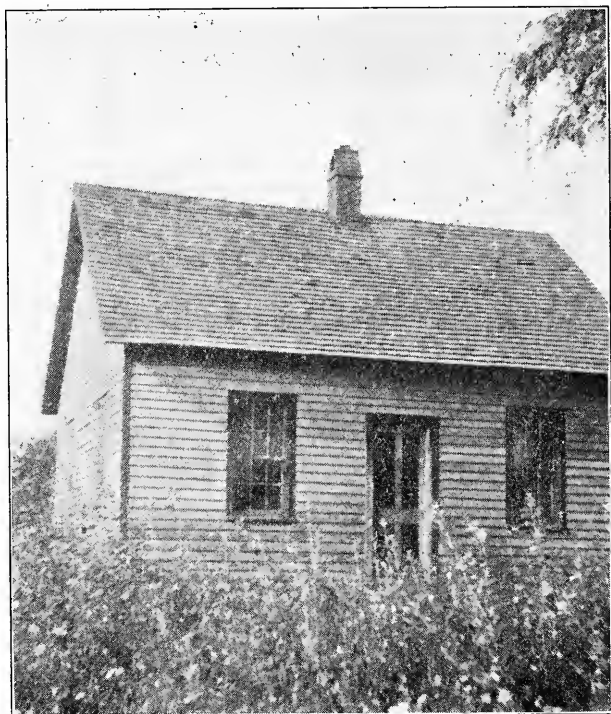
BLACKISTON'S NO. 137
(Colored)

Score	Perfect Score
I. Site	32	160
II. Building	53	200
III. Service Systems	21	250
IV. Class Rooms	50	225
V. Special Rooms	0	165
	<hr/>	<hr/>
	156	1000

This is a one-room frame building with unprotected entrance on the long axis of the building. It is in a dilapidated condition, and the entire surroundings are unsuited to the needs of the community. The grounds are overgrown with briars and bushes, and the entrance to the grounds is so low that at the time of the survey the building was almost inaccessible. The class room is lighted on three sides and is supplied with the very minimum of ancient and mutilated equipment.

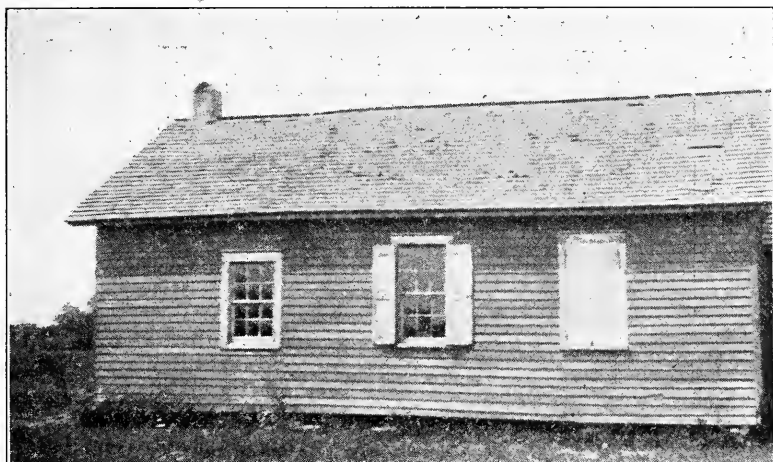
BLANCO NO. 138

Score	Perfect Score
I. Site	48	160
II. Building	39	200
III. Service Systems	19	250
IV. Class Rooms	49	225
V. Special Rooms	0	165
	<hr/> 155	<hr/> 1000

This is a one-room frame building, 18x30, with vestibuled entrance. The site is too small for present needs and is so located as not to be convenient of extension. The building scores but 19 points out of 250 on service systems and offers a minimum of class room facilities. The score by individual items and totals is sufficient justification for the recommendation that the building be abandoned.

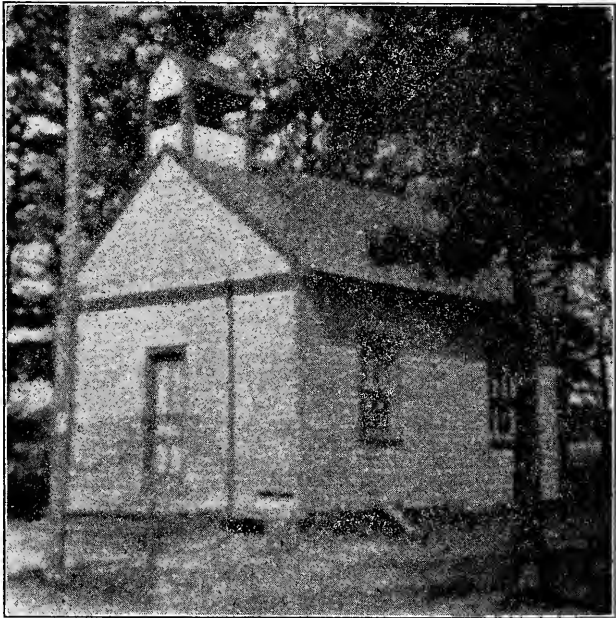
SANDFIELD NO. 141
(Colored)

Score	Perfect Score
I. Site	50	160
II. Building	30	200
III. Service Systems	21	250
IV. Class Rooms	52	225
V. Special Rooms	0	165
	<hr/> 153	<hr/> 1000

This is a very old frame building of the box type with open foundation. The building is 16x20, and the size of the site is indeterminate because of the fact that it is located in the woods, only the underbrush having been cut away to allow for the placement of the building. The elevation of the land is such that should this site be made permanent a large clearing would make a fairly desirable school site. The score of 30 out of 200 points on the building proper is indicative of the fact that little loss would be entailed in the complete abandonment of the building.

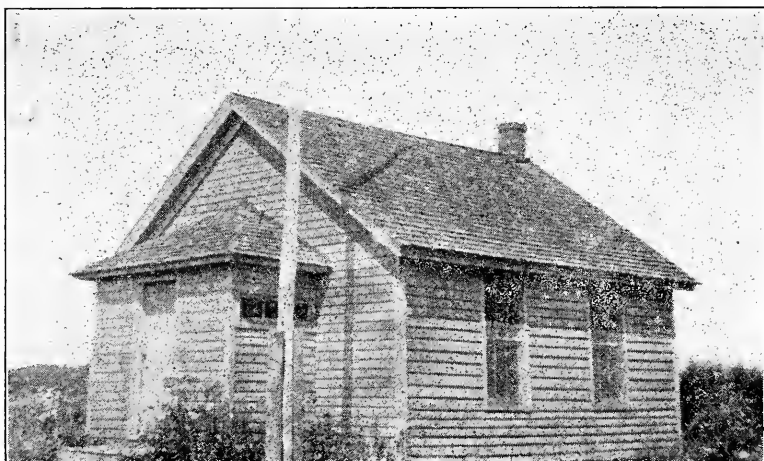
MARYDEL NO. 153

The Marydel colored school is a one-room frame building, 18x20, located on a small indeterminate school site, joining a church yard. The building is very old and in a dilapidated condition. It is heated by a box wood stove and offers absolutely no facilities in the way of water supply or toilet systems. The class room and class room equipment are of the meagerest type and utterly unfit for use. The building should be closed and the children transported to a new building constructed upon a suitable site.

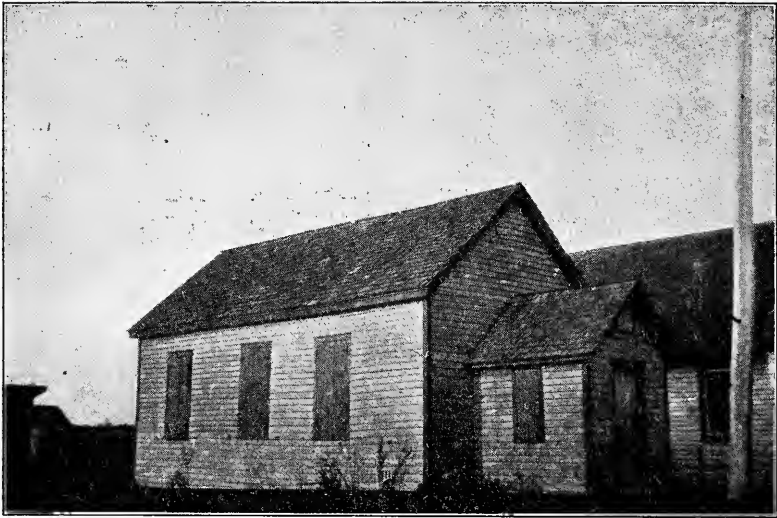
ELLENDALE SCHOOL

Score	Perfect Score
I. Site	26	160
II. Building	30	200
III. Service Systems	37	250
IV. Class Rooms	46	225
V. Special Rooms	3	165
	<hr/>	<hr/>
	142	1000

This is a very old, one-room, vestibuled frame building, 14x28, on a brick foundation in very bad condition. It is located in a churchyard and offers little opportunity for play or recreational facilities. Service systems are either entirely missing or of the most meager type possible. The class room is small, dirty and in general uninhabitable. The glass area is low and distributed on

three sides of the room, one of which the children are compelled to face. The building should not be used for school purposes and cannot be made by alteration into an acceptable school building.

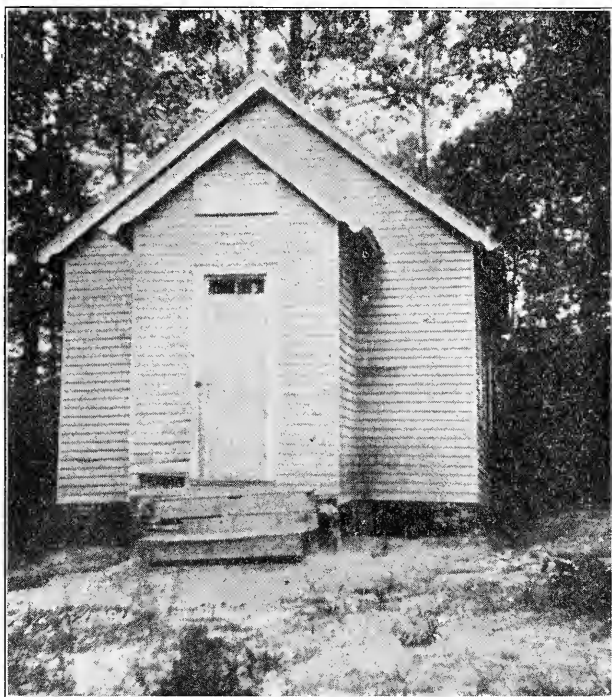
MILLSBORO SCHOOL

This is probably as poor a school building as can be found in

Delaware. Its score of 111 points indicates that practically nothing exists about this school which is worthy of mention. Torn, ragged, out-of-date maps are samples of the type of equipment. A floor full of holes and patched in places by nailing on a second layer of broken board indicates in what condition the interior of this structure was found. Weeds were actually growing through the floor of the schoolhouse. The majority of the blackboards were painted wooden boards with a large part of the paint worn off. The building is located in what was once a clearing on a forest road, in the midst of a dense forest. The clearing had become overgrown to such an extent that it was impossible to see the outhouses, if there were any, from the road. The State of Delaware should not permit this building to be used as a schoolhouse a moment longer than it will be necessary to build a high-grade, modern plant for these children.

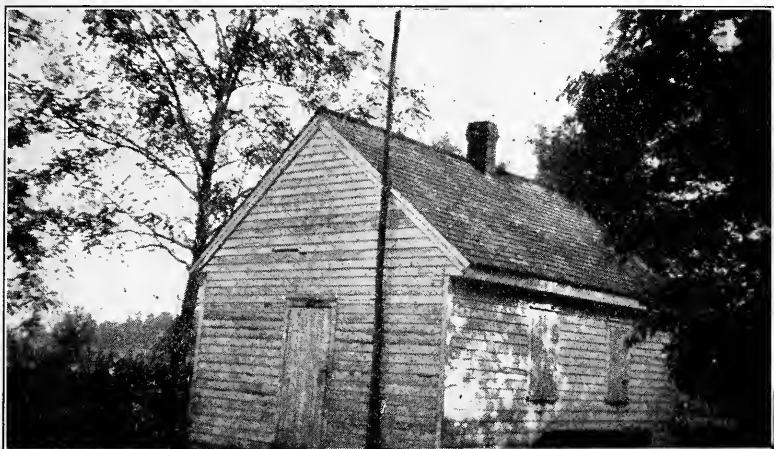
WHARTON SCHOOL

Wharton's Branch Colored School is housed in a very old one-room, one-story frame building, which is located on a small, irreg-

ular site, approximately 100x150 feet, surrounded on three sides by oak woods and underbrush. The building is 14x20, of the non-vestibuled type, lighted from three sides with the seatings so arranged as to compel the children to face an open window. The entire structure is in the last stages of decay. From the exterior one would never suspect that school children would be housed in such quarters. The

interior is no more satisfactory than the exterior. The ceiling is seven and one-half feet high and the floor, which is badly worn, is sagging down at either end to such an extent that it is out of level by as much as twelve inches. This building has absolutely nothing to recommend its continued use for school purposes, and everything to warrant the recommendation that it be closed, and that in its place a modern school structure be provided.

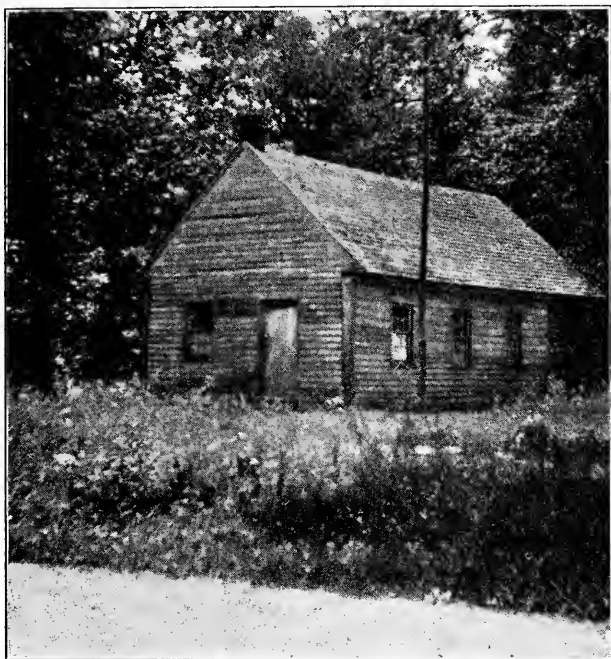
TRINITY SCHOOL

Score	Perfect Score
I. Site	30	160
II. Building	17	200
III. Service Systems.....	19	250
IV. Class Rooms.....	52	225
V. Special Rooms.....	0	165
	<hr/>	<hr/>
	118	1000

This building is a one-room frame structure, without vestibule. It is approximately 18x32 feet in dimensions. The character of the foundation could not be ascertained without the removal of boards, which were buried in the ground. The roof is moss-grown, and the entire building is in the last stages of decay. It is located in a churchyard at the intersection of poorly graded, unimproved roads. The building is heated by a box stove. It has neither clock nor bell; no provision has been made for either drinking or washing facilities and no toilet accommodations whatever are provided. The glass area of the class room is less than one-half of what it should be, and what it has is distributed on opposite sides of the room. No window shades are supplied and no provision made for cloak rooms. The only commendable feature of the building is the new double desks which have been installed. These are in good condition, but double desks do not meet standard requirements. This building

should be abandoned absolutely and the children of the community provided with a new and modern schoolhouse.
